Refurbishing TR6 Door Switches

Ron Weber

Central PA Triumph Club

March 7th, 2007

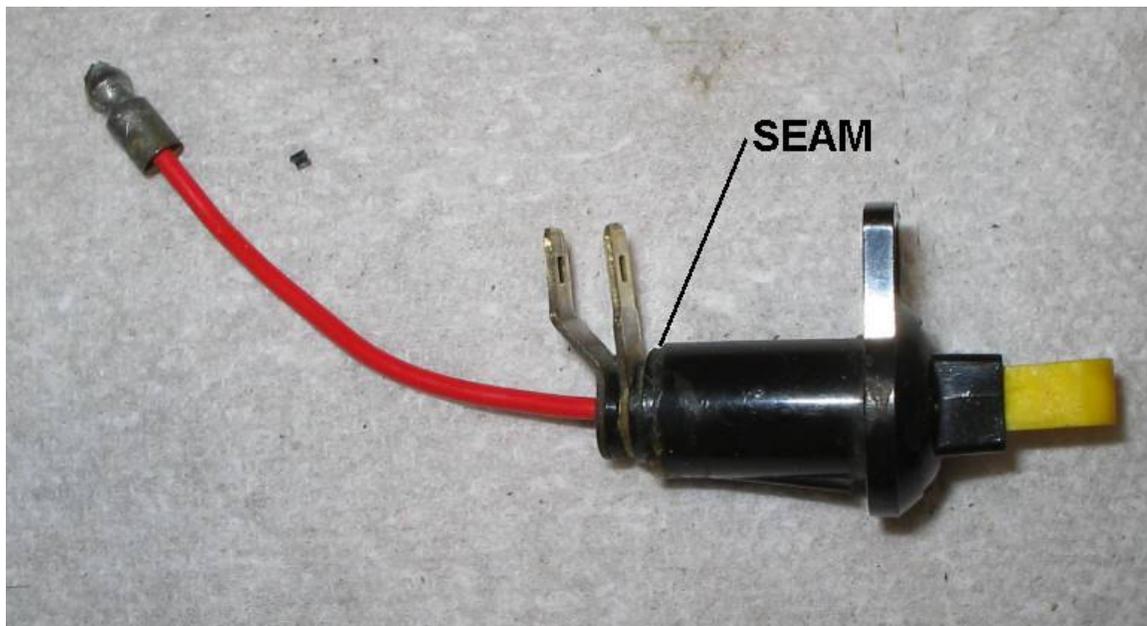
Figure 1

Well, the switch is broken anyway so I began to figure out a way to dissect it. After looking at the switch, I (wrongly) concluded the front of the switch is a cap that can be simply popped off. A half hour and one bugged up switch later; I discovered my assumption was wrong. After looking at it a little further, I discovered a seam at the back end of the switch that was covered by grime (see fig 1 of a "new-er" but also defective switch).

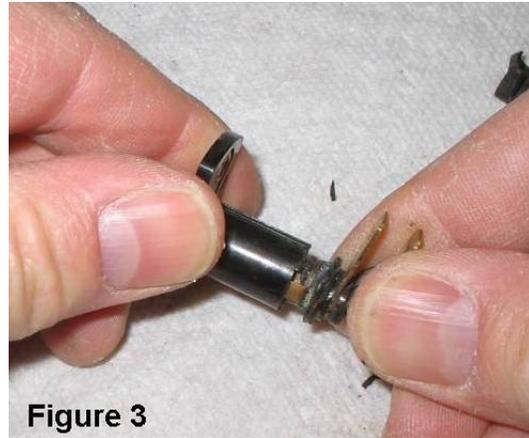
The next step is to gently rock the inner switch assembly back and forth by the tabs while pulling on the switch body. There's still a little glue in between the two that still needs to be fractured. After 35 years of aging, the glue is brittle but so is the plastic so be patient! Eventually, it will break free and pull out as shown in figure 3. DON'T immediately pull it all the way out.

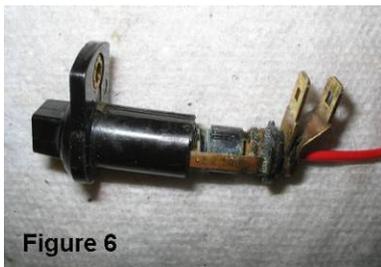
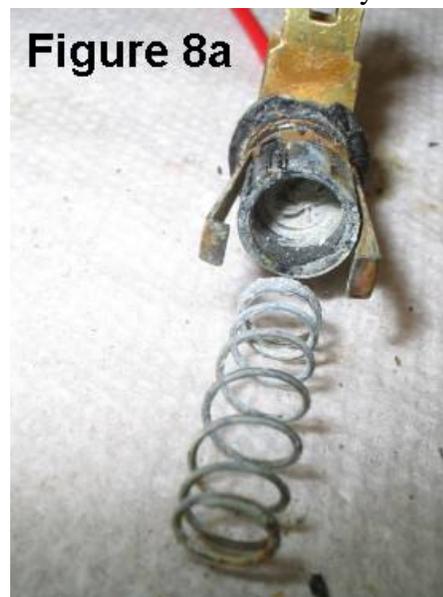
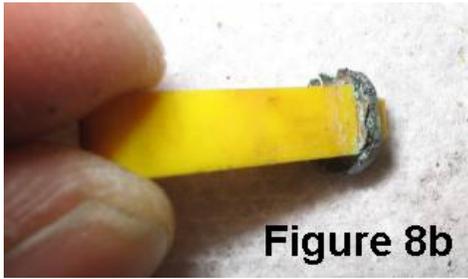
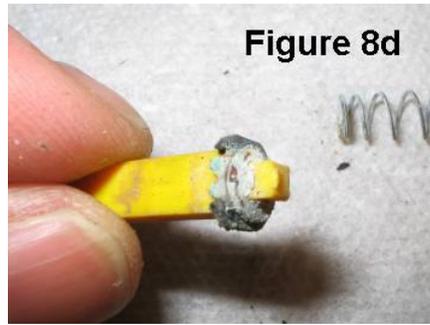
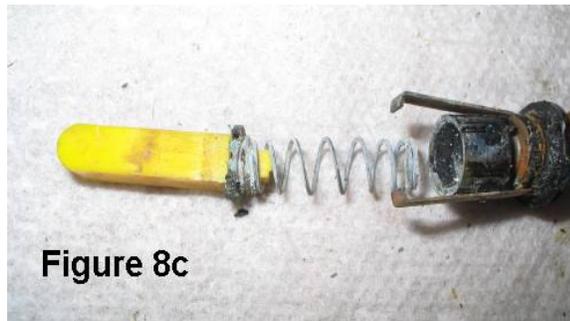
At this point, you'll probably see a lot of corrosion on the contacts as seen in fig 6-8 below. It also uncovered why one circuit works and the other doesn't. The switch truly is a poor design and it amazes me it even worked to begin with. By nature of the contact arrangement, both sets of contacts attached to the plunger need to contact three different points at the same time for the switch to work. Through normal stress relaxation of the metal and corrosion buildup, eventually, one of the contact points bends away further than the others and the switch no longer works.

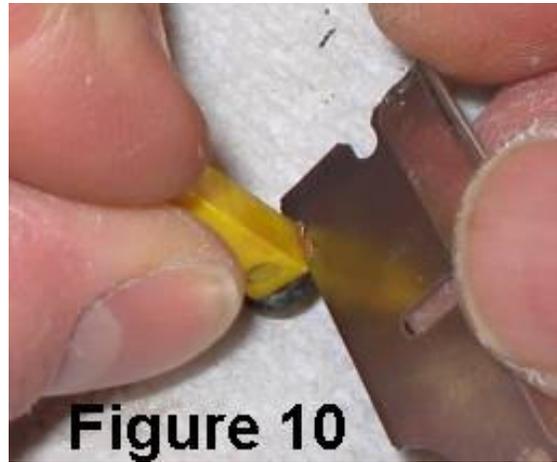
Next, using a razor blade, gently pry each set of contacts on the plunger forward slightly as shown in figure 10. Aside from the corrosion, I believe contact over-stress is the main reason one set of contacts may work and the other doesn't.

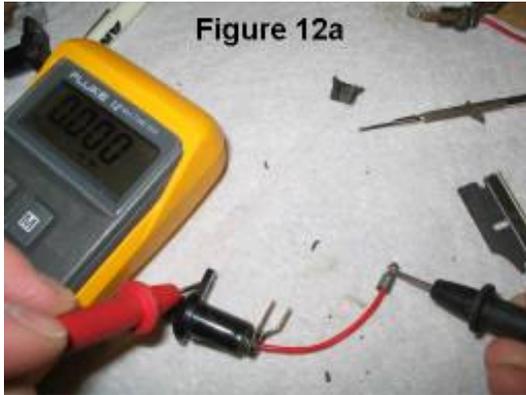
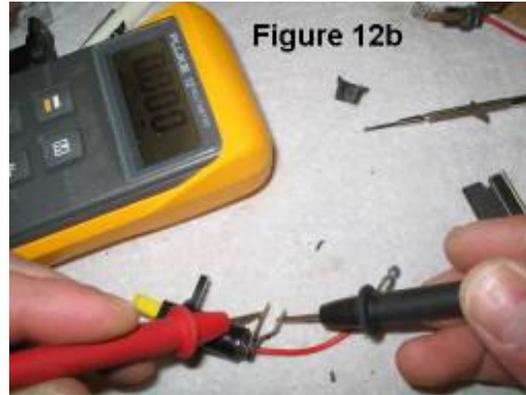
The last step is to reassembly the inner switch assembly into the switch body. Check continuity between the circuits. At this point, you'll probably have only one set of contacts closed but this is not a problem. Depress the plunger and let the switch quickly snap closed a few times. This "seats" the contacts and slightly re-bends them to fit. Recheck with a meter and repeat until you get continuity on both circuits as shown in figure 12a & 12b.
